UNDERWATER FACILITIES  
INSPECTIONS  
&  
ASSESSMENTS

U. S. NAVAL STATION  
GUANTANAMO BAY, CUBA

AUGUST 1980

PERFORMED BY:  
UNDERWATER CONSTRUCTION TEAM ONE

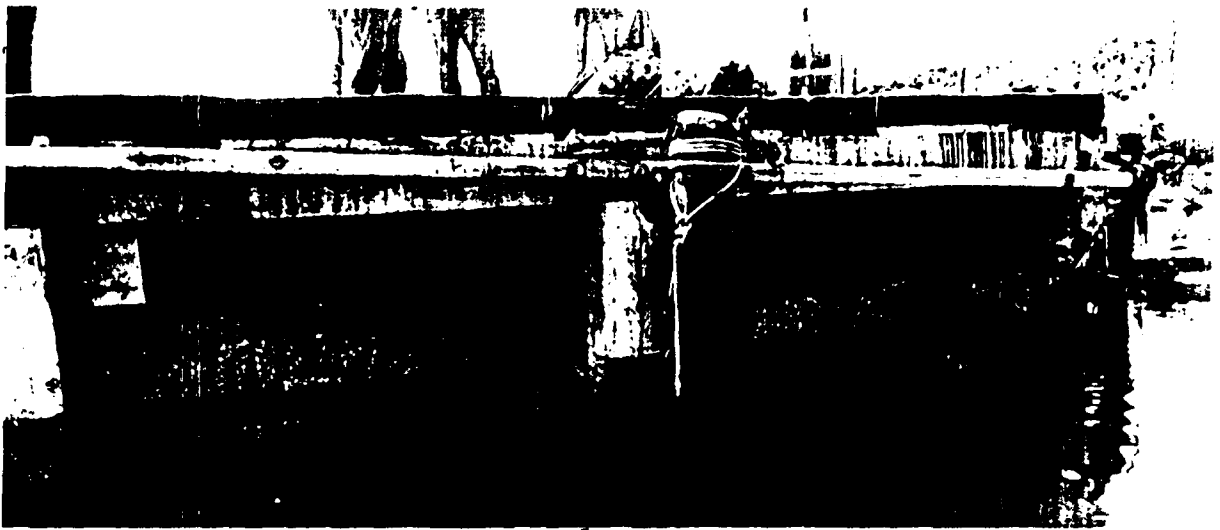
FIGURE 1

EXPOSED REINFORCING BAR OF PILE CAPS AND DECK BEAMS, PIER D

- o Repairs to the deteriorated concrete be initiated, as soon as possible.

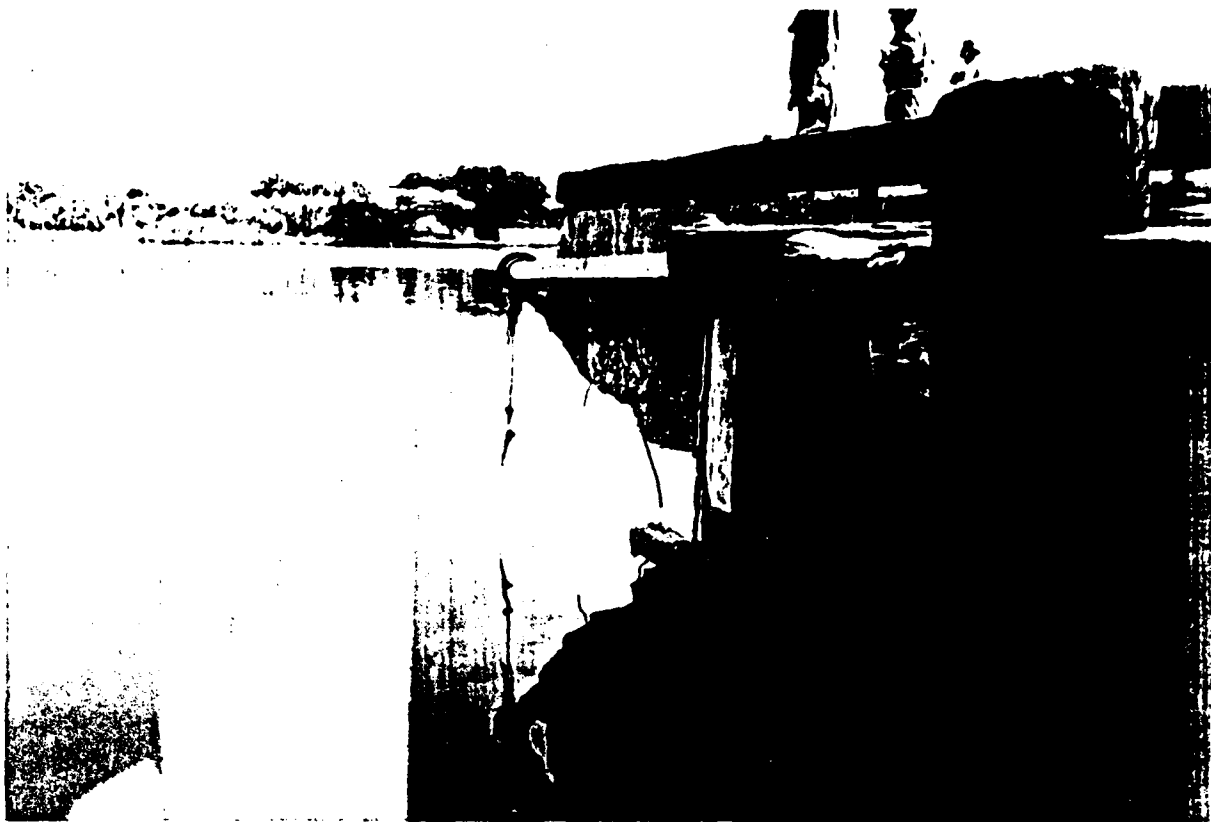
FIGURE 20

DESTROYED FENDER SYSTEM; PIER D

- o The present system of floating wood camels be removed from contact with the pier and that a camel system be designed and installed in a manner that is not detrimental to the structure.
- o The fender system be repaired and maintained to prevent destruction of the pier support system.
- o The pile tops be treated and capped to prevent fungus rot.
- o Dolphin piles be removed or repaired and protected to prevent degradation by limnoria attack.
- o Deck hardware be protected by isolation or protective coatings applied to prevent accelerated degradation by concrete. Deck hardware degrades because it is anodic to the passivated steel within the adjacent concrete.

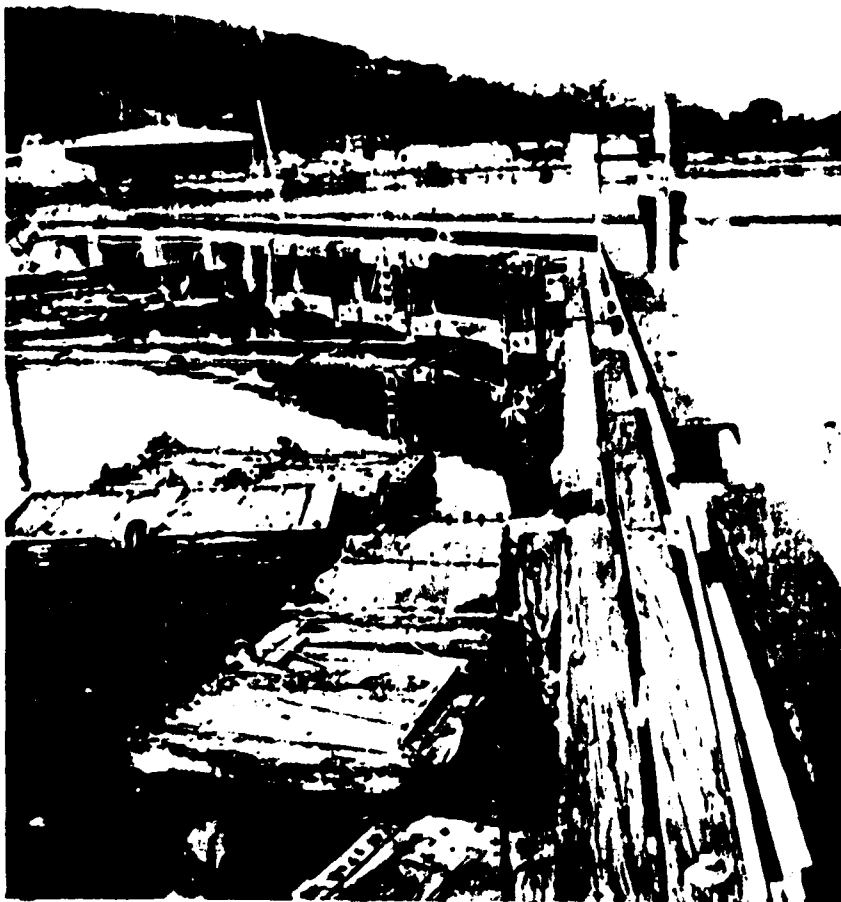
FIGURE 22

DESTRUCTIVE CAMEL SYSTEM; PIER D

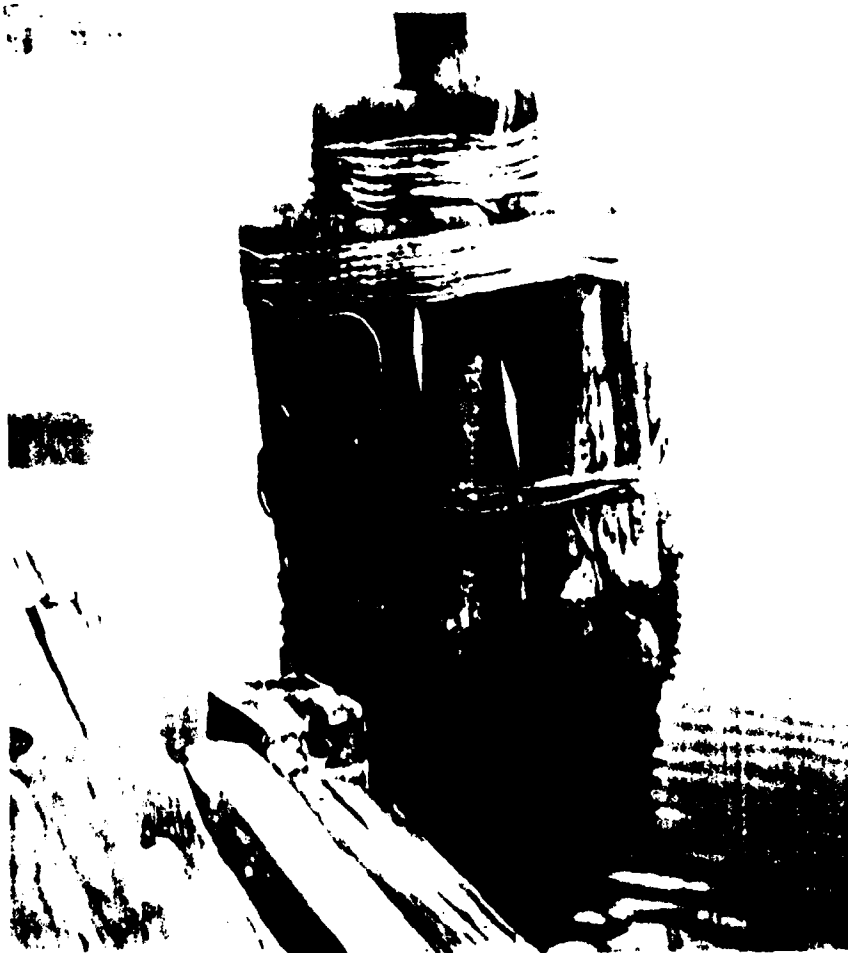
FIGURE 24

LIMNORIA ATTACK AND FUNGUS ROT OF  
DOLPHIN PILES; PIER D
